1 **EFFECTIVENESS ASSESSMENT OF RISK REDUCTION MEASURES AT COASTAL AREAS USING A**
2 **DECISION SUPPORT SYSTEM: FINDINGS FROM EMMA STORM**

10 **Abstract**

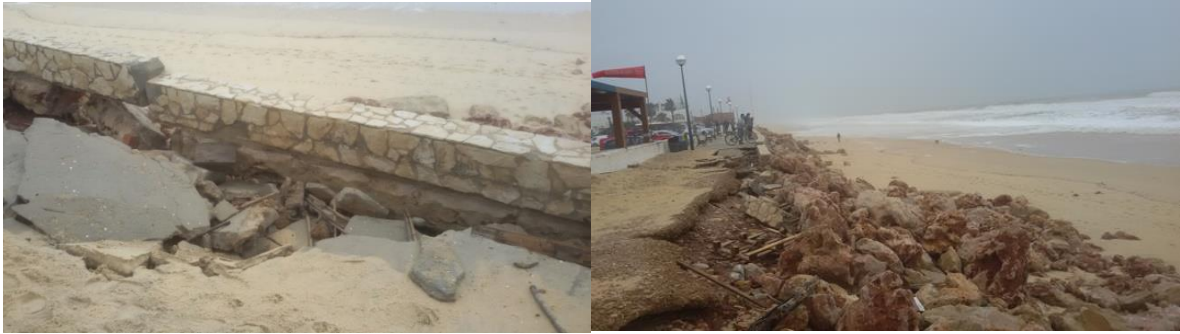
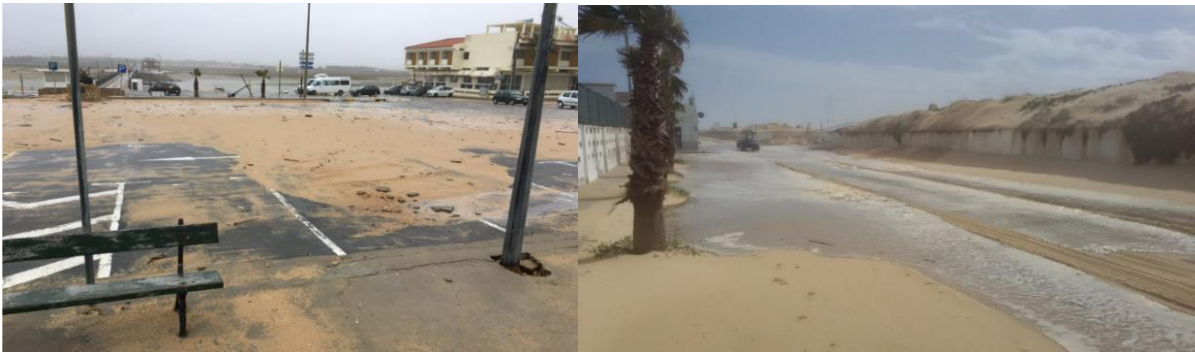
190 Figure 4. Examples of Emma storm effects at Faro Beach: seafront promenade and wall destroyed
191 behind the rip-rap seawall (upper images), overwashed roads and car parks with inland sediment
192 transport by wind and waves (lower images).

183 The Emma storm had a strong erosive effect at Faro Beach and was also responsible for overwash at
 184 specific (and lowered) areas. While overwash was responsible for piling up water and sediment over
 185 roads, at car parks and house yards, the erosive character was responsible for the damage of walls
 186 and promenades, and threatened houses placed at the front line (Figure 4).

246 It must be stated that no rigid features have been implemented at the modelling. The permeable rip-
247 rap seawall that limits the upper beach at part of the study area (see Figure 4 upper images) was
248 incorporated by using an increased friction at the boundary between the beach and the dune/car
249 parking. The use of a hard layer at the model would completely avoid coastal retreat or damage behind
250 the rip-rap seawall, which would not fully represent the effect of this coastal protection at Praia de
251 Faro (see Figure 4, upper images).

352 Regarding infrastructures, 3% of the total longshore model domain presented infrastructure damages,
 353 namely stairs and promenades (see Figure 4), while about 11% could be considered potentially
 354 damaged (vertical erosion at the infrastructure but without collapse). These values are in good
 355 agreement with the ones expressed by the modelling and trained BN (Table 3). The protective effect
 356 of the rip-rap seawall did not completely avoid infrastructure destruction since it is a permeable
 357 seawall and most of these structures were placed in front (seaward), above or immediately behind
 358 the rip-rap seawall and thus have been directly affected by the storm.

362 Figure 4). Along the car parking area, the predicted mean overwash water flux was 0.22 m²/s with
 363 maximum values of 0.7 m²/s at the western edge of the car park. For overwash, the BN/Model
 364 estimated damages on 0% of the houses, 98%-99% of safe houses and 1%-2% (Table 4) of potentially
 365 damaged houses (overwash velocities between 1-3 m/s), while for infrastructures only the BN predicts
 366 damages or potential damages and for only 4% of the area. The field survey allowed the identification
 367 of minor damages that could be partially attributed to overwash (e.g. scour of the pavement
 368 surrounding the lamppost at the central image of Figure 4). Nevertheless, several infrastructures and
 369 houses (hotels and restaurants mainly) were directly overwashed (see Figure 4 for examples),
 370 suggesting a slight underestimation of the overwash.

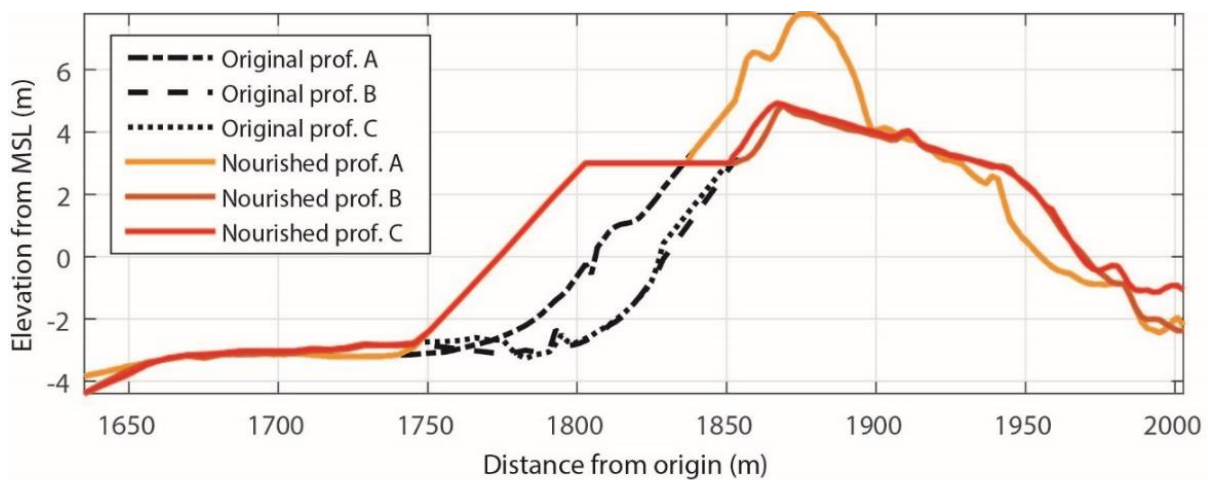
265 Figure 5. (a) Original (black) and nourished (color) profiles along Faro Beach; (b) Vertical elevation
 266 differences between the replenished and the original beach topo-bathymetry for the model domain;
 267 (c) Original nearshore bathymetry of the model domain. Dashed lines shows the profile's location.

- 256 A) Current situation (no DRR measure in place)
- 257 B) Beach nourishment including the construction of a circa 45 m wide berm (Figures 5 and 6)
- 258 C) Removal of the houses (Figure 6) placed at the ocean side of Faro Beach (between the main
259 road and the beach)
- 260 D) Beach nourishment (B) + House removal (C)

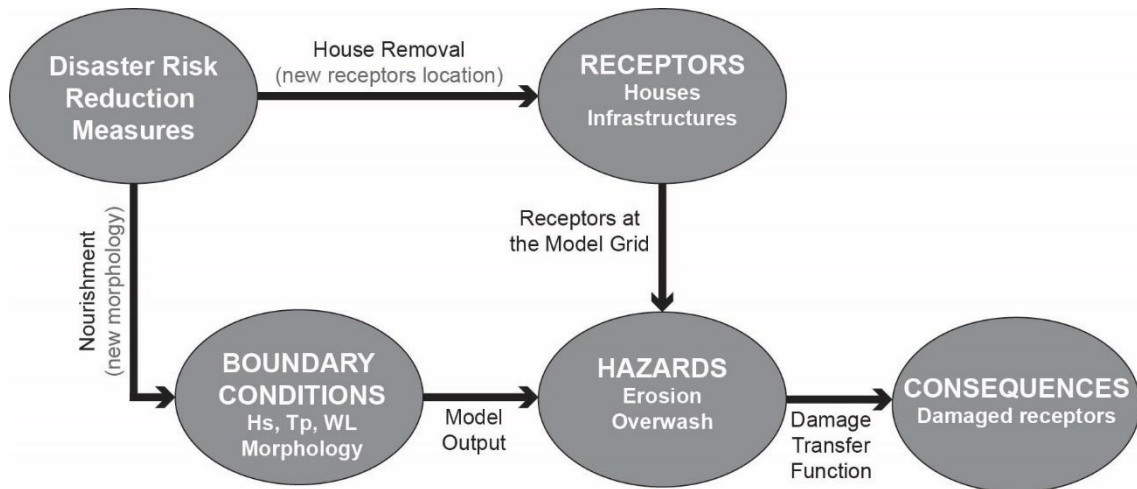
270 Figure 6. Design of the Decision Support System with the implementation of two Disaster Risk
 271 Reduction measures: Nourishment, changing the boundary conditions and the modelling outputs;
 272 House Removal, changing the receptors' location.

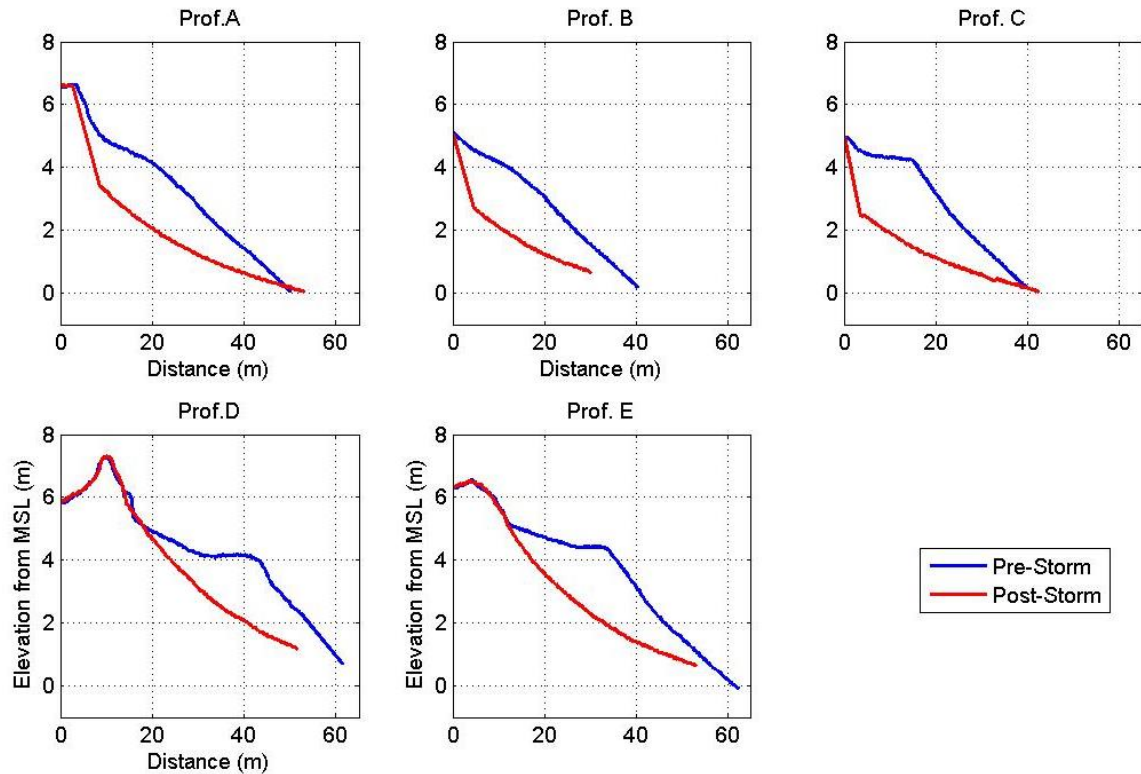
318 Figure 7. Measured pre- and post-storm profiles along Praia de Faro for the storm Emma. Profile
 319 locations are given in Figure1.

300 Emma storm produced the total removal of the beach berm and a maximum vertical erosion higher
301 than 2 m along the entire study area (Figure 7), exposing the rip-rap seawall and destroying some
302 existing infrastructures (e.g. seafront promenade, walls, stairs to access the beach). The volume
303 eroded from the upper part of the beach face (above 1 m MSL) is presented in Table 1. The measured
304 profiles seems to pivot around mean sea level or slightly above, and thus the measured values are
305 inferior to the total observed erosion of the upper beach profiles. It can be observed that along Faro
306 Beach the erosion volumes were similar, ranging from 51.6 m³/m to 60.3 m³/m, with an average value
307 of 56.3 m³/m. Differences on erosion values can be attributed to the initial profiles variability, namely

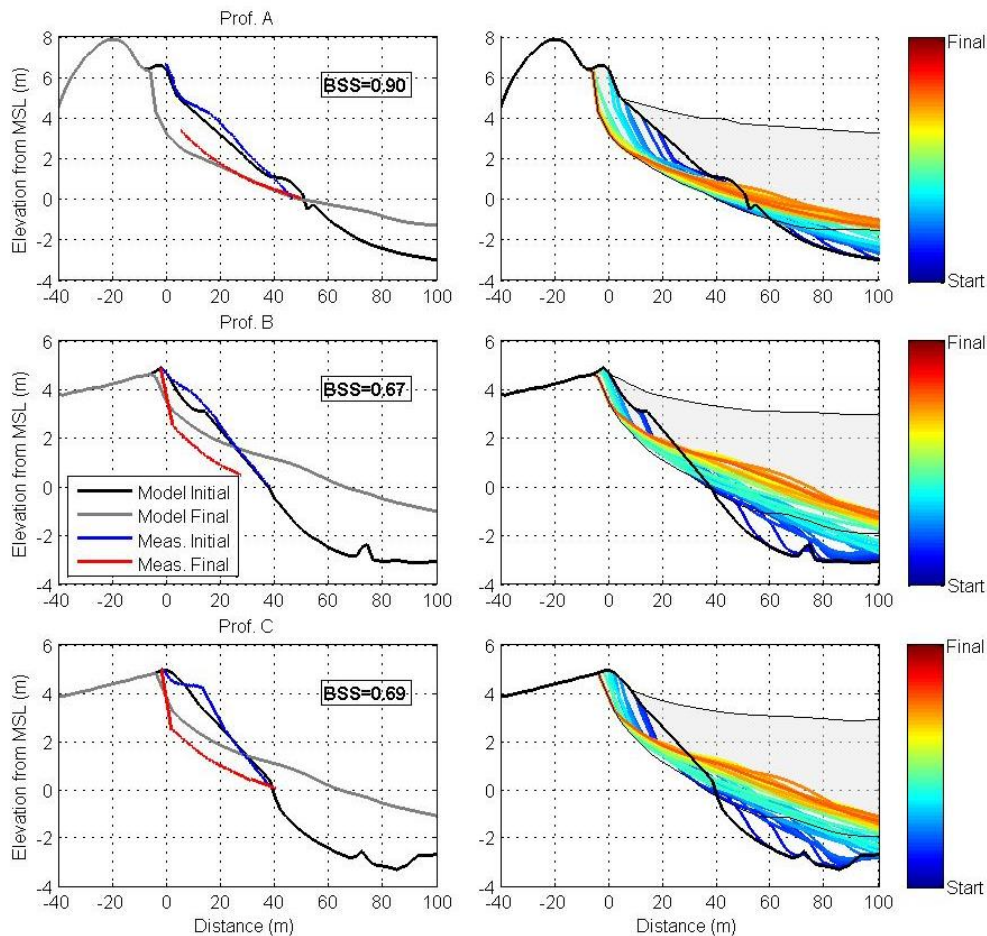
350 Figure 8. XBeach model validation (left panels) for profiles A to C. Profile evolution during the storm
 351 (right panels) for the same profiles. Shaded areas on the right panels represent the water envelope.

429 The modelling validation proved that the obtained results with XBeach are reliable for Faro Beach and
430 Emma storm (see Figure 8). Predicted erosion and overwash by Emma modelling and trained BN, as
431 well as the estimated damage (or potential damage) of houses and infrastructure (Tables 2 to 5,
432 scenario A), are generically in agreement with field observations. A relatively small part of the
433 houses/infrastructures were effectively damaged, mostly by erosion, as modelled. The predicted
434 potential damage (mainly by erosion) of 24-31% of the houses and 13% of the infrastructures was also

444 assumption) of the current methodology that can be solved in the future by integrating different topo-
445 bathymetric conditions at the modelling. It can be seen in Figure 8 that differences between initial
446 modelled and measured profiles are relatively small and mainly due to alongshore cusps that can be
447 frequently observed in the area. In the present case, volume differences between the initial profiles
448 varied between 8 and 16 m³/m, which represents a change of 14-28% of the average eroded volume,
449 and thus that can be assumed as the average error associated to the variability between measured
450 and modelled initial profiles. A potential improvement of the method will be to consider different
451 possible initial morphologies and analyse the potential storm consequences under a range of
452 morphologies.
