To cite this article: Stefan Rosendahl and Marta Marçal Gonçalves 2020 *IOP Conf. Ser.: Mater. Sci. Eng.* **960** 022065

# Building Problems in Architectonic Heritage and Geotourism: Is there a Connection?

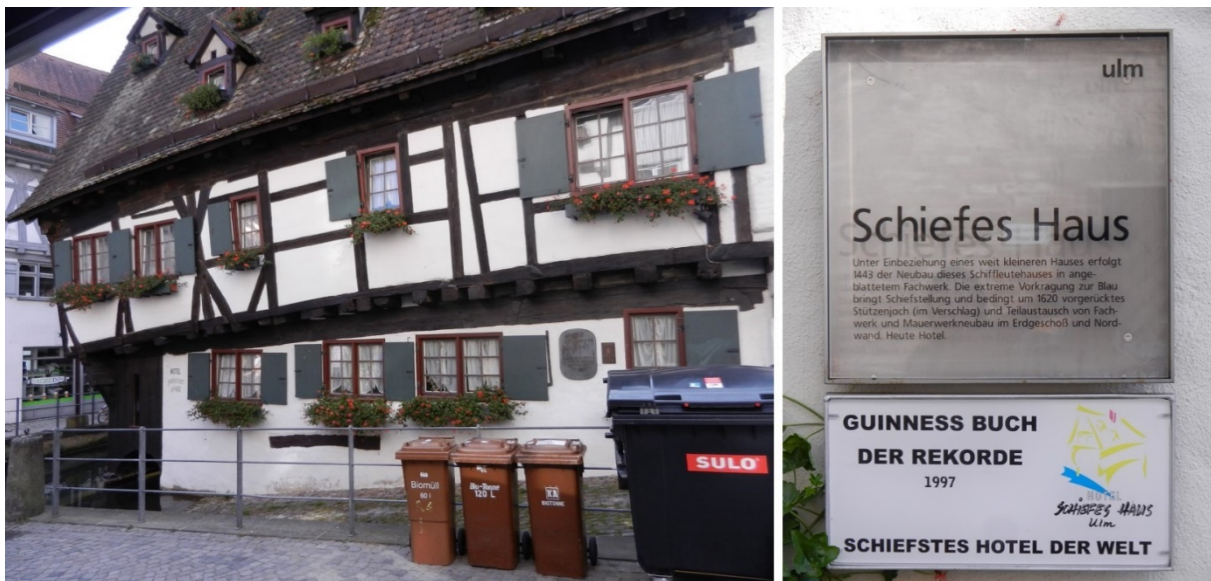
In this neighbourhood, you find the Hotel Schiefes Haus ("Crooked House"), which has been awarded by the Guinness Book of Records in 1997 as the "Most Crooked Hotel of the World" (Figure 3). The half-timbered house was completed during the 15<sup>th</sup> century in the late gothic style. The northern part was built on Pleistocene glacial gravel deposits, relatively stable, which can reach a thickness of up to 11 m near the confluence of the Blau stream and the Danube River [17]. However, the southern part of the building was founded on Holocene alluvial deposits (gravel, sand, silt and clay), which are less firm than the gravel deposits [18].

**Figure 3.** Left: Building of the hotel “The Crooked House” at Ulm (Germany). Right: Table with the Guinness Records Award “Most Crooked Hotel of the World”. Source: Authors.

Consequently, the weak substrate of the southern side, as well as the high groundwater level (two sides of the house are located directly at the waterfront of the Blau stream channels), allowed a heterogeneous settlement of the ground and the house was put in a crooked position. Moreover, the overhang of the southern wall over the channel worked as a lever which pressed this side of the building deeper into the ground (Figure 3). There were taken measures to stabilize the structure, like installing pillars, replacing wooden walls by stone walls, reinforcing the fundamentals with concrete, moving weight from the southern to the north side, but the house remained in its crooked condition [18].

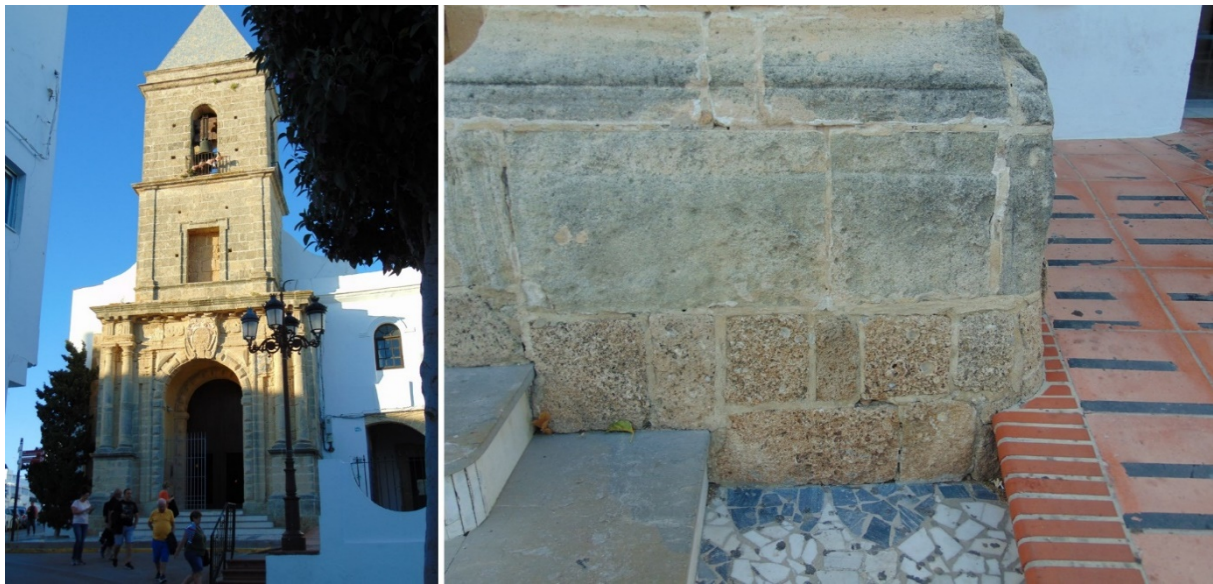
At the church of Our Lady of the Virtues, a layer of blocks made of coarse limestone with large open pores is visible near the ground (Figure 4). In the authors' opinion, this layer was installed as a horizontal barrier against the capillary rise of water, because this process only works in material with small pores whose diameters are less than 0,5 mm [20]. Other methods to prevent capillary moisture rise are the installation of a drainage system; the use of a horizontal barrier made of impermeable material, as it was done in Venice during the Middle Age, where a layer of blocks made of very poorly permeable Istrian Limestone was collocated between the wooden pillars and the brick walls of the buildings; or to rise the floor as it was done in some medieval churches [20].

**Figure 4.** Church of Our Lady of the Virtues of Conil de la Frontera (Spain). Left: Façade with Renaissance portal. Right: Basic layer made of limestone blocks with large pores as a probable barrier against capillary moisture rise. Source: Authors.

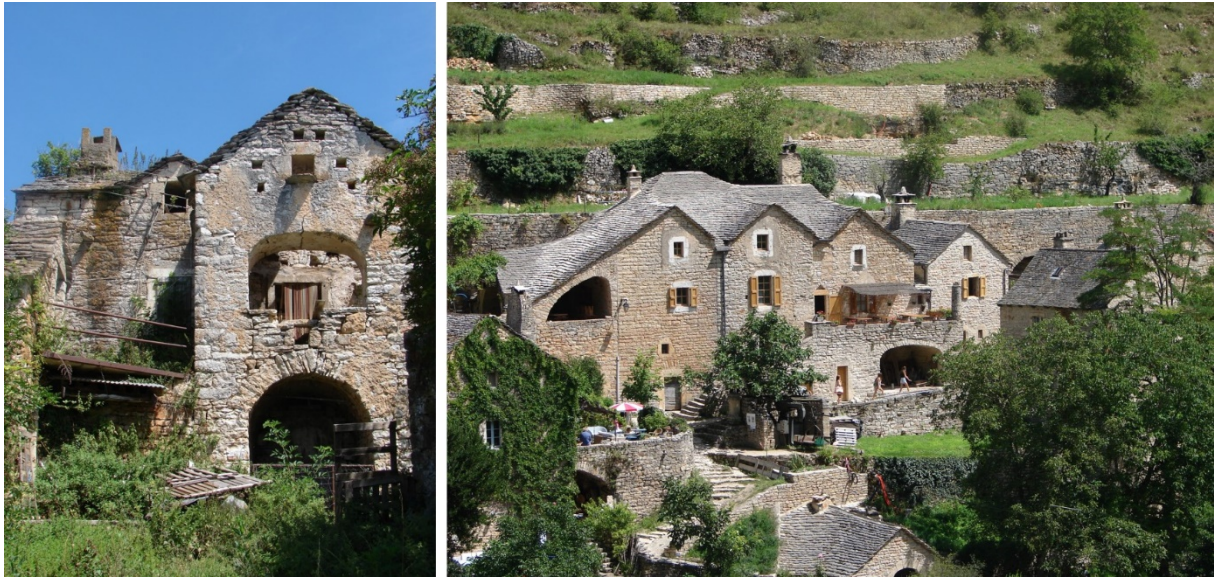
Due to the lack of wood for geological reasons, the rural architecture is dominated by limestone. The carpenter work in traditional buildings is reduced to a minimum, floors made of wood in other regions are substituted by stony arches made by limestone blocks (Figure 5). This technique allows the floor to bear great loads, particularly as the houses' coverage is made of limestone shingles, also using a minimum of wood [21]. Besides the few trees growing in the region, the disuse of wood has another reason: Due to the water shortage, there is hardly an alternative extinguishing agent to water in the case of a fire in the house. This is all the more true since many houses are single, with the next neighbour often living some kilometres away.

**Figure 5.** Farm houses in the Causse region. Left: Abandoned farm house in Causse de Sauveterre, with arches made of limestone blocks and roof made of limestone shingles. Right: Agglomeration of houses in the Tarn River gorge. Source: Authors.
