Decision Framework for the  
Design and Construction of  
Autonomous Artificial Reefs

**UNIVERSIDADE DO ALGARVE**  
**FACULDADE DE CIÊNCIAS E TECNOLOGIA**  
2018

**Master in Marine and Coastal Sciences**

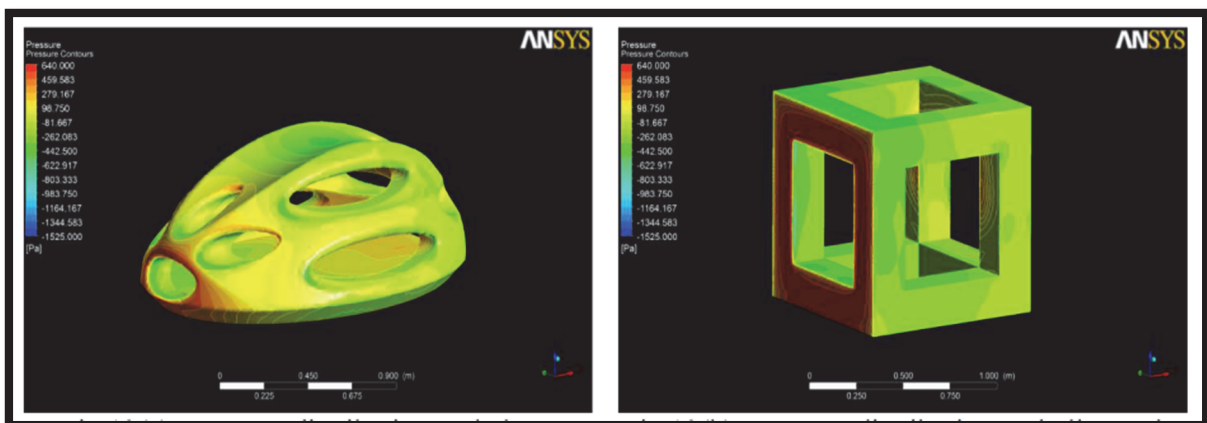
Figure 2.1: Pressure distribution of artificial reef for a flow direction of 0 degrees (Yaakob, 2016).

In a study conducted by Yaakob et al. (2016), engineers worked to understand the differences in shear stress of a traditional hollow cube artificial reefs and a newly developed and streamlined “helmet-shaped” design which included rounded edges to increase its hydrodynamic properties. Here they found that a design which incorporated more rounded edges experienced lower wave, inertial and drag forces than the more traditional cubic design. An image of this can be seen in Figure 2.1. An artificial reef with low flow dynamics would improve fish and marine organism’s ability to shelter, reproduce and even hunt in and around the artificial reef (Yaakob, 2016).

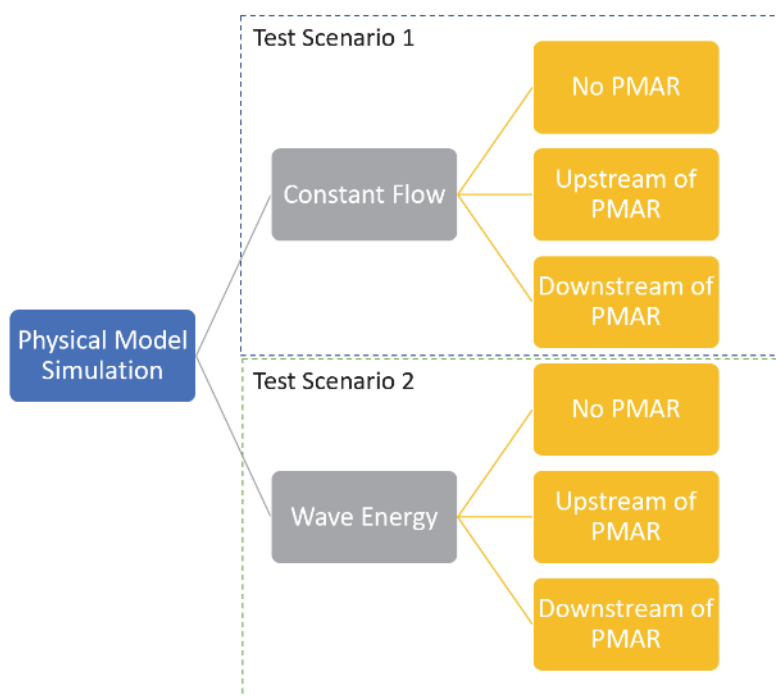
Figure 3.4: Visualization of testing breakdown structure

During each of these eight tests, one of two scenarios were used. The first scenario modeled a constant flow environment. The second scenario modeled a high wave energy environment. Each scenario required three different testing stages where data was collected. The first stage measured the flow velocities without the PMAR. The second stage measured flow velocities upstream of the PMAR. The third stage measured flow velocities downstream of the PMAR. A single test consisted of one scenario and three stages. Figure 3.4 illustrates the testing breakdown structure.

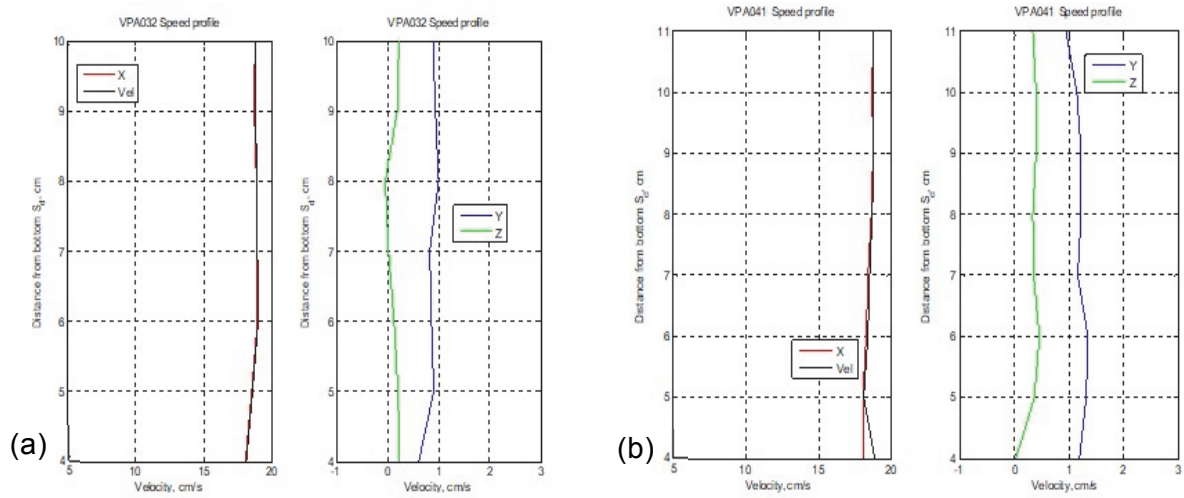
Figure 4.2: Velocity profiles in the x, y and z directions for VPA032 (a), VPA041(b) from position 9.

bottom. The z-direction velocities in VPA041 were held steady at around 0.4 cm/s and decreased to 0 at the bottom.

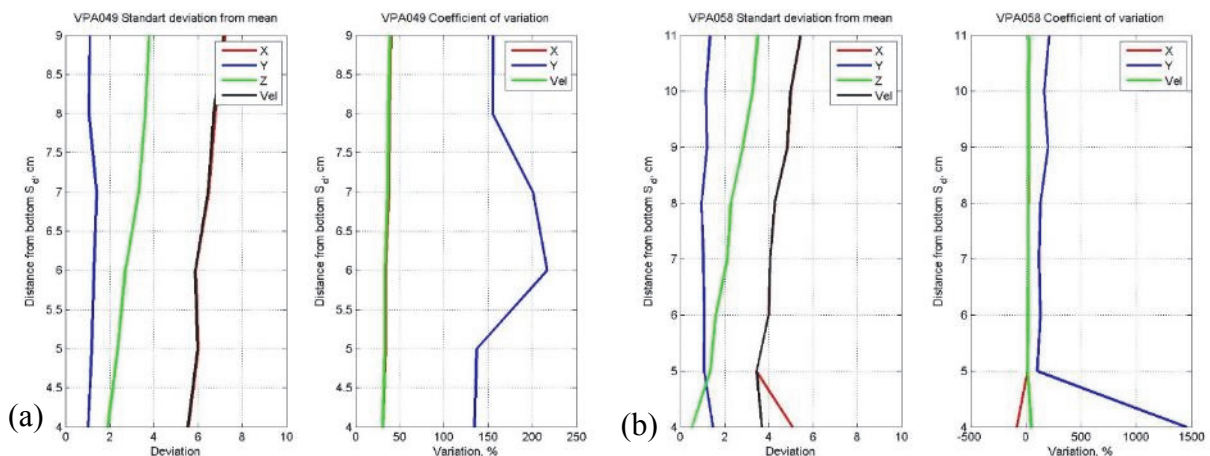
Figure 4.5: Statistical data for tests VPA049 (a) and VPA058 (b)

The statistical data concerning deviation from the mean and coefficient of variation can be seen in Figure 4.5.

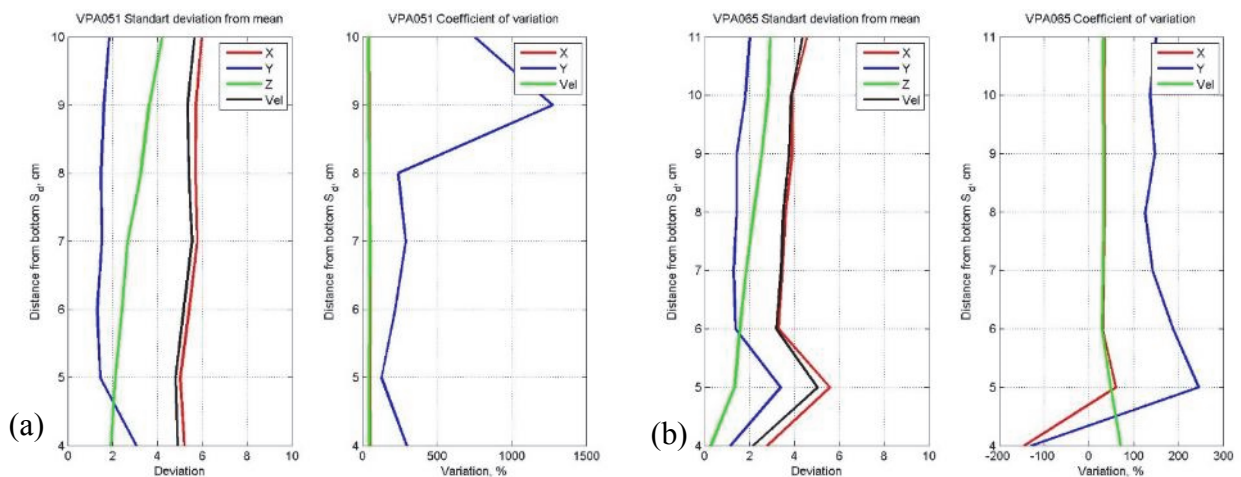
Figure 4.18: Statistical Data from VPA051(a) and VPA065(b)

The statistical data concerning deviation from the mean and coefficient of variation can be seen in Figure 4.18.

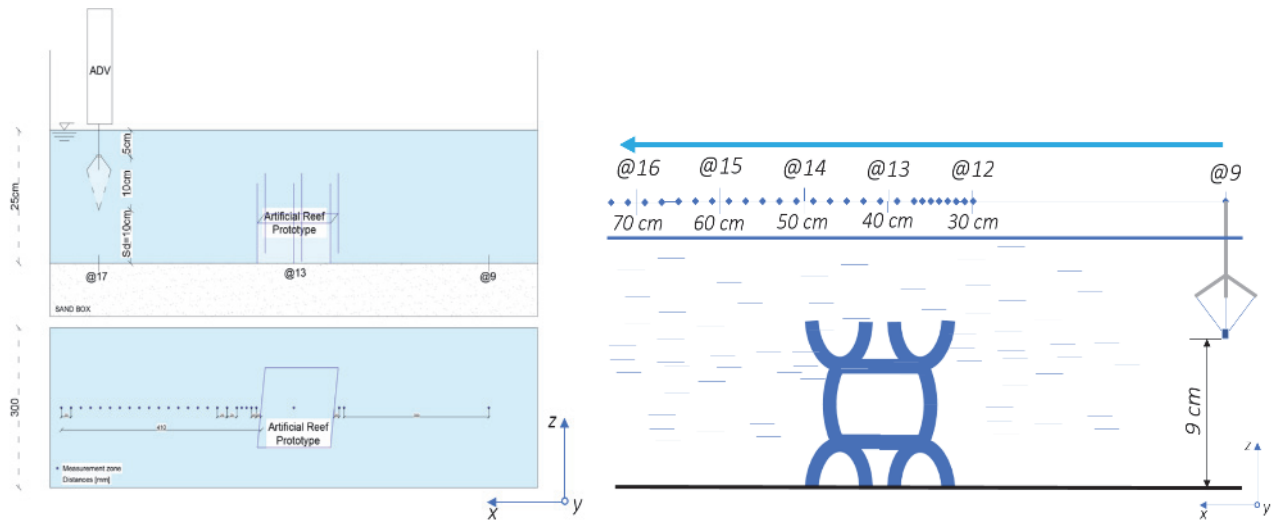
Figure 4.24: ADV fixed in the z direction and travelling along x direction for measurements

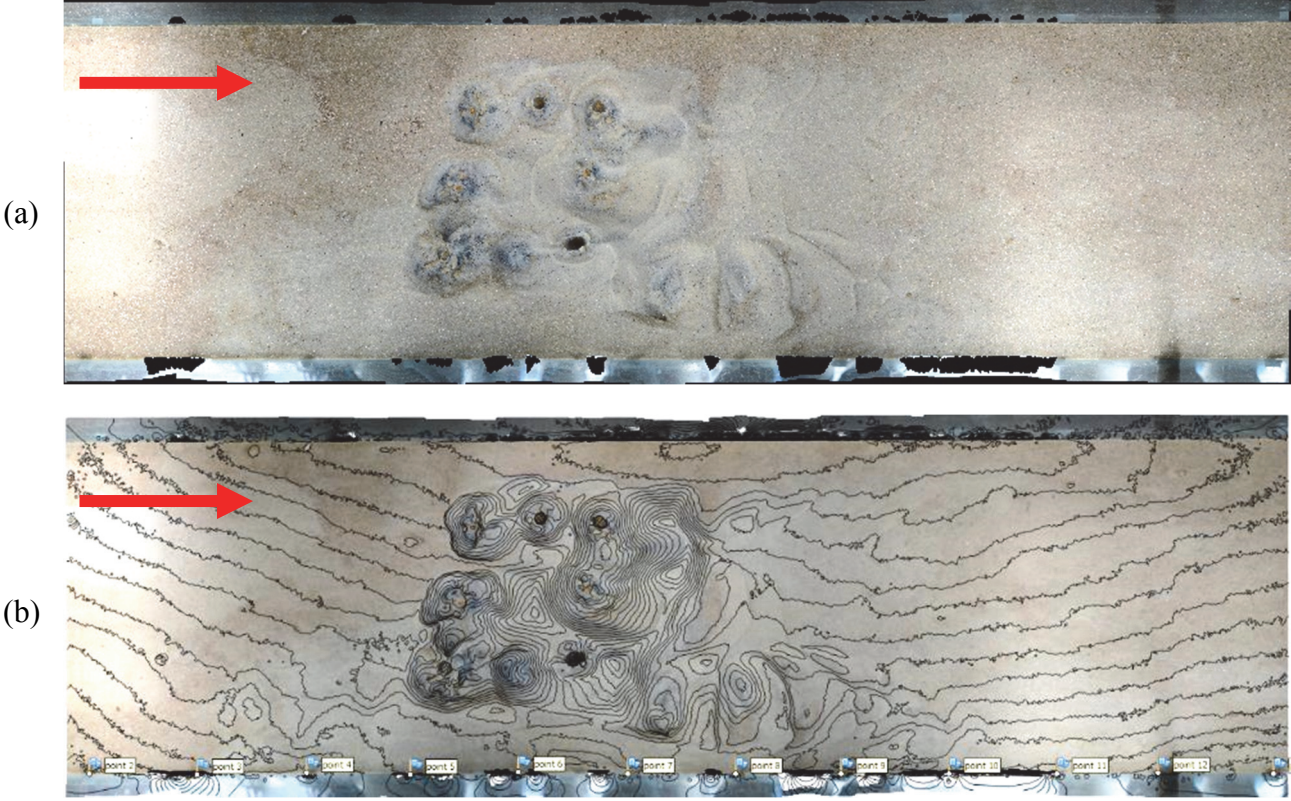
Figure 4.30: Reconstructed digital orthomosaic model from test 2: without (a) and with contours line (b). Red arrow indicates direction of water flow.

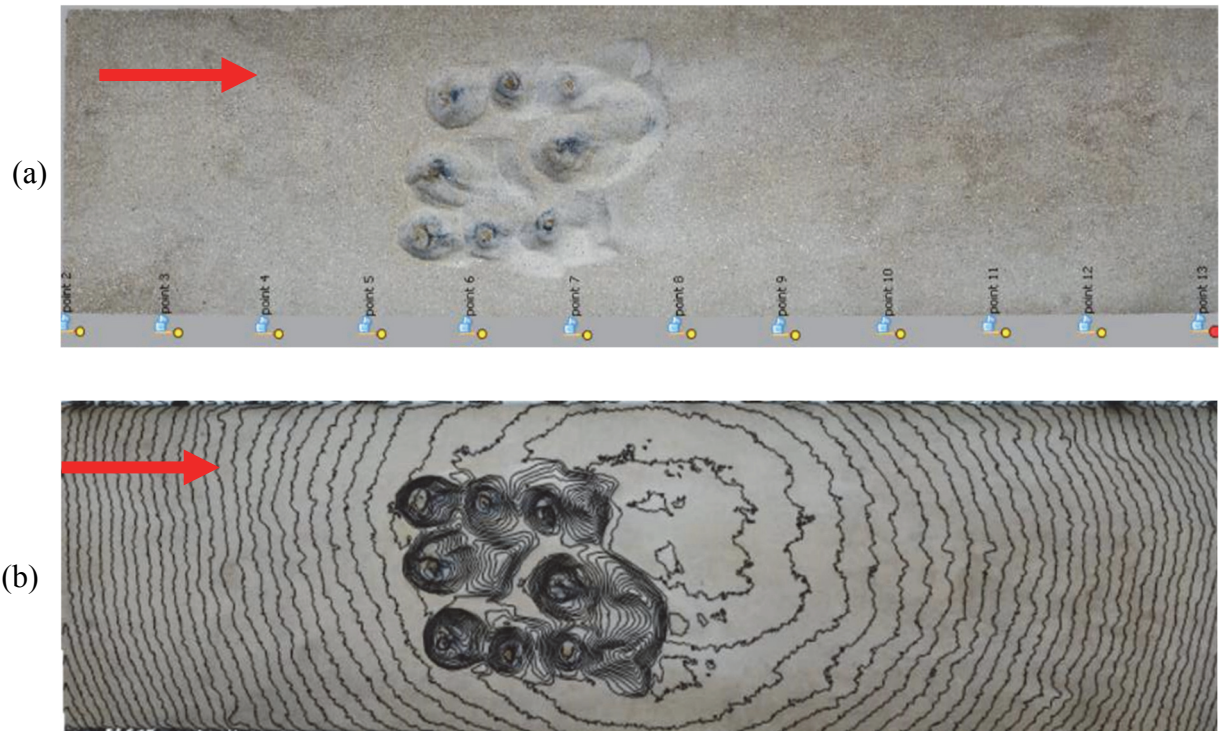
Figure 4.33: Reconstructed digital orthomosaic model from test 3: without (a) and with contours line (b). Red arrow indicates direction of water flow.

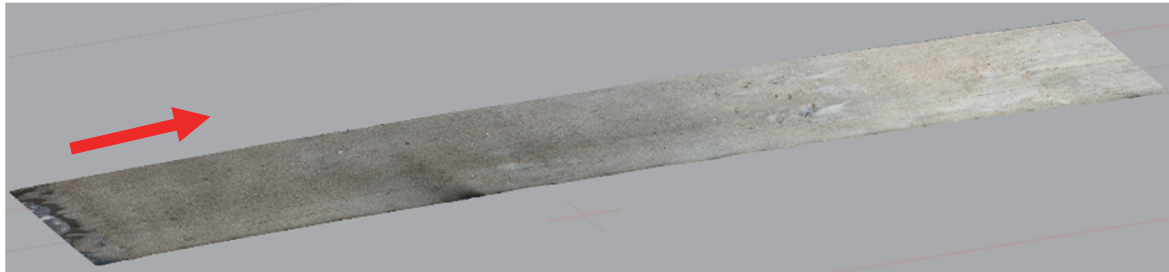
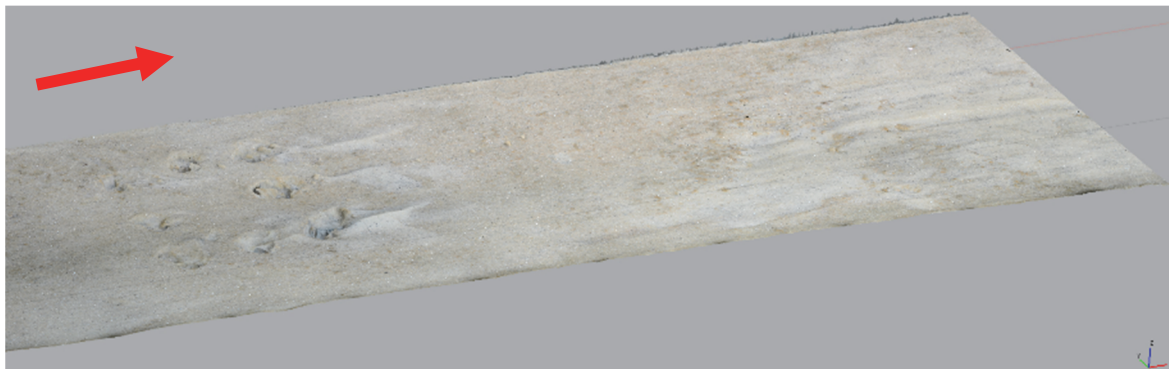
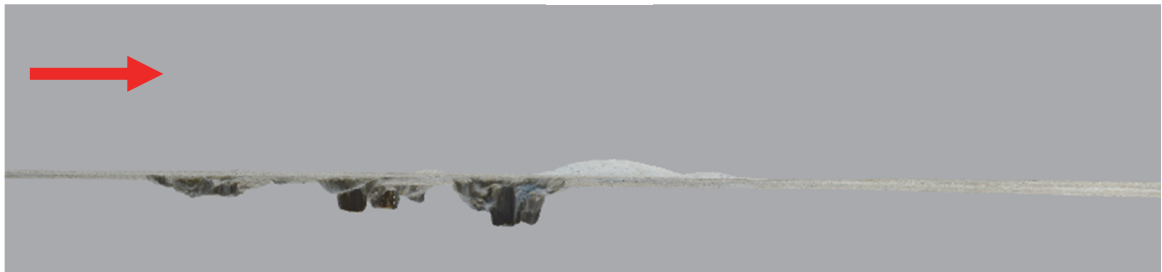
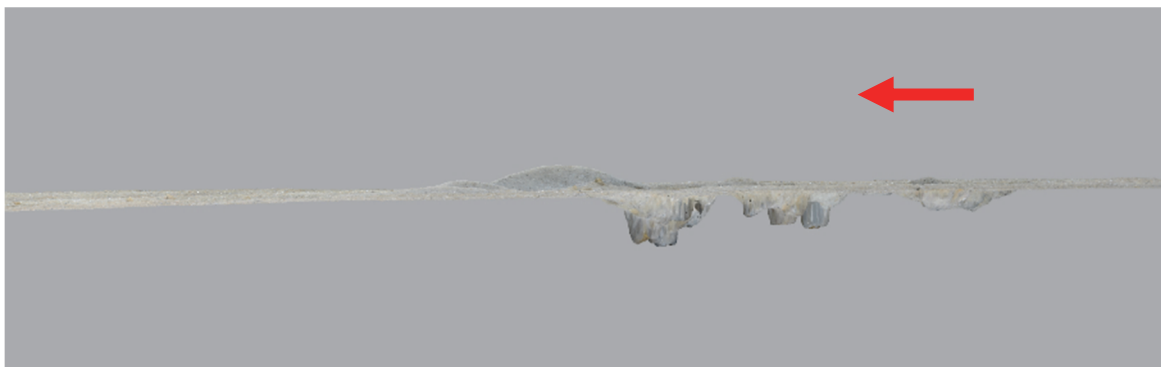
Through stitching together, the individual photos taken after the completion of test 5, the following images were recreated, Figure 4.37. A reconstructed digital model, as seen from the top and side, show the erosion and scouring patterns from the test.

Figure 4.37: Reconstructed digital 3D model from test 5: perspective (a) and side view (b). Red arrow indicates direction of water flow.

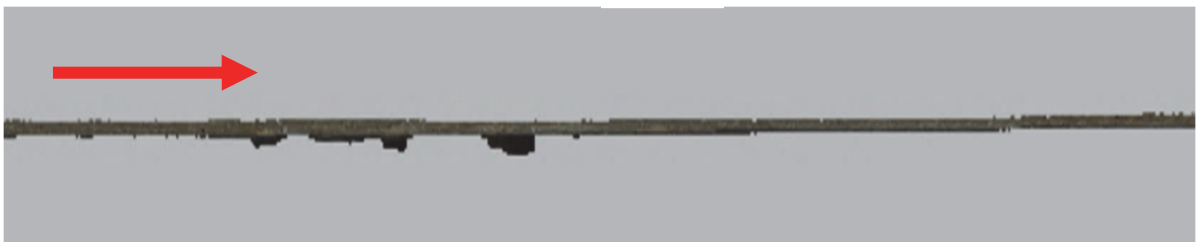
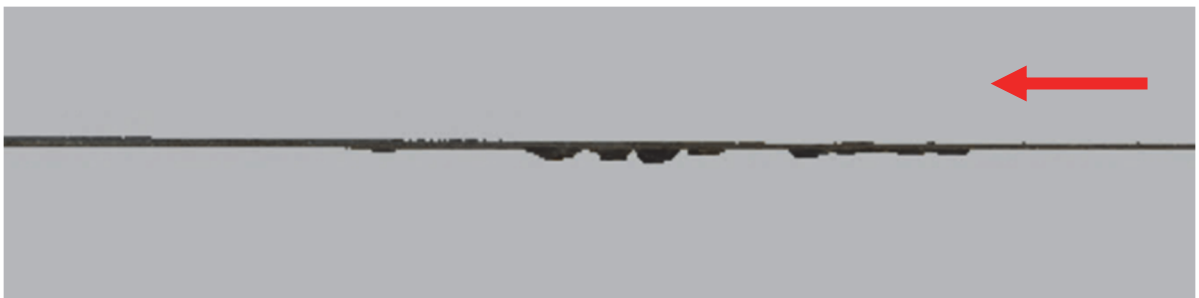
Through stitching together, the individual photos taken after the completion of test 6, the following images were recreated, Figure 4.40. A reconstructed digital model, as seen from the top and side, show the erosion and scouring patterns from the test.

Figure 4.40: Reconstructed digital 3D model from test 6: perspective (a) and side view (b). Red arrow indicates direction of water flow.

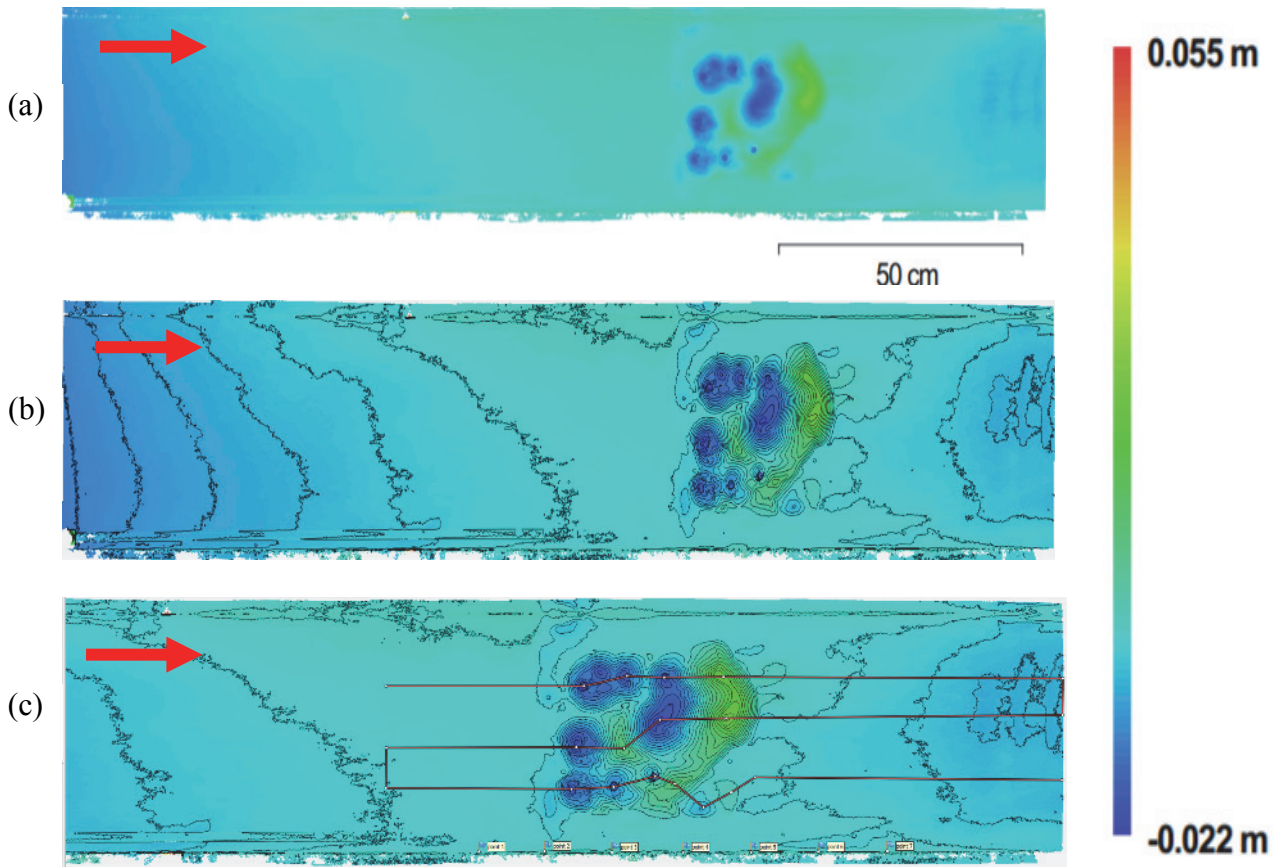
Figure 4.47: Reconstructed digital elevation model from test 8: without (a) and with contour lines (b, c). Red arrow indicates direction of water flow.

Reconstructed digital elevation maps were then generated out of this 3D model, Figure 4.47. For test 2, the elevation varied between - 0.021 and 0.058 m. Contour lines were added if images b and c at a space of 0.002 m. Figure 4.47c shows the track line for depth measurements taken. In these maps, negative values indicate areas of erosion and positive values indicate areas of accretion. These values can be found in the Appendix, Figure 7.

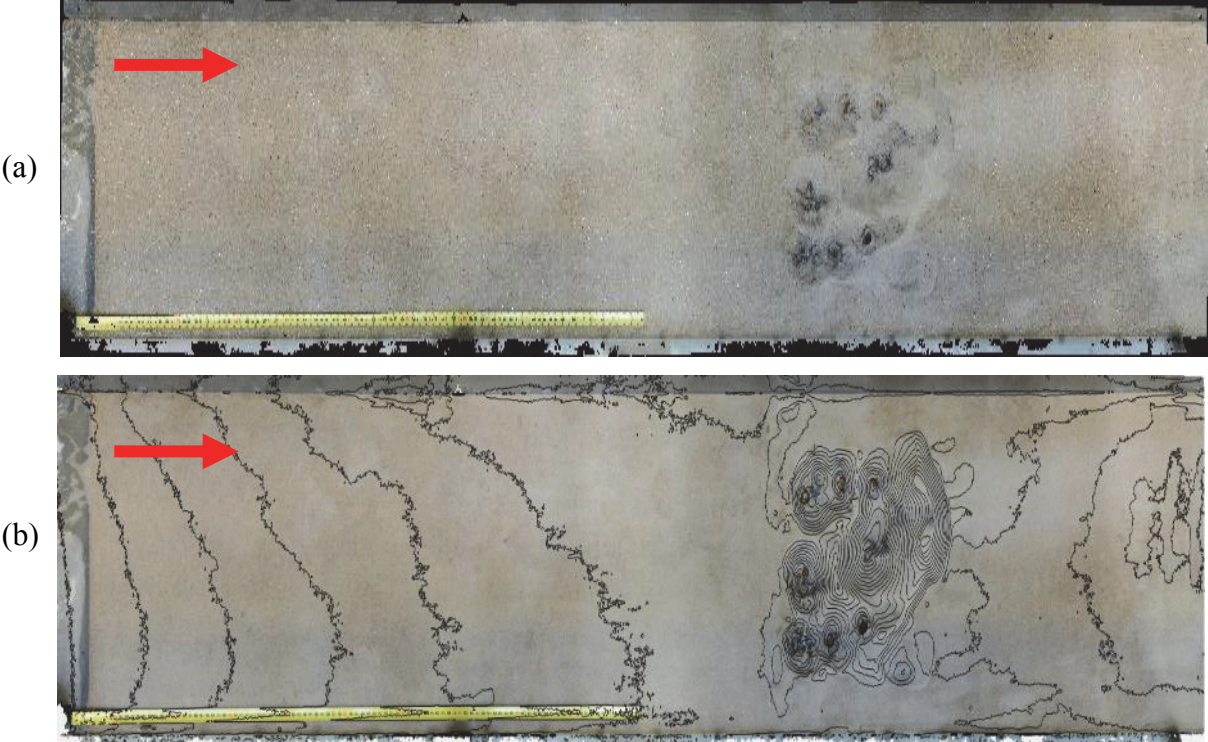
Figure 4.48: Reconstructed digital orthomosaic model from test 8: without (a) and with contour lines (b). Red arrow indicates direction of water flow.

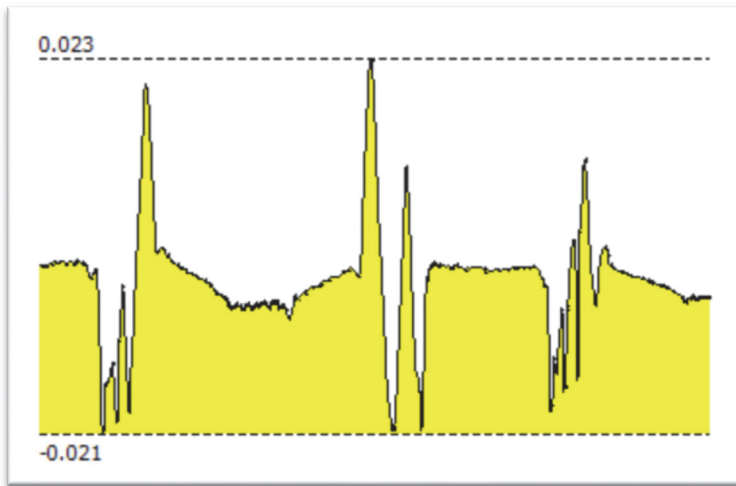
Figure 7: Reconstructed Digital Elevation Model depth data from Test 8
