Research article

The effectiveness of elevated boardwalks in restoring coastal dunes

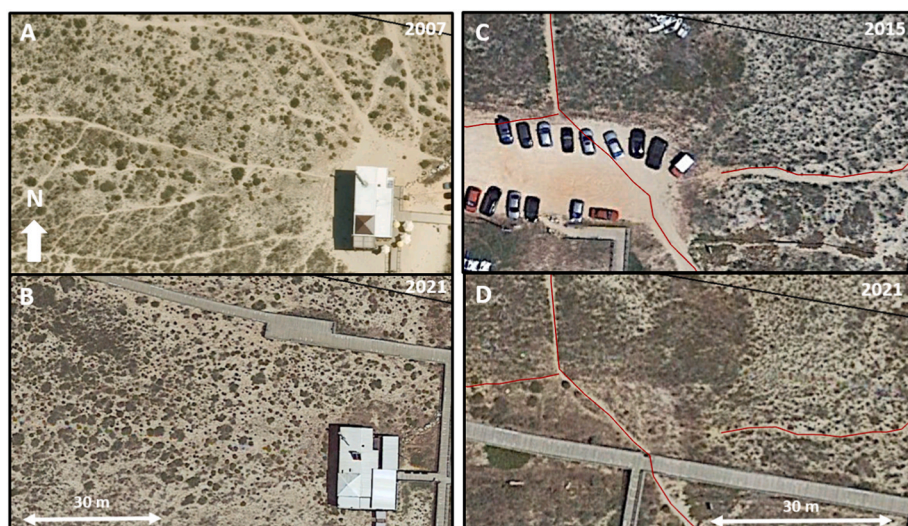
Fig. 3. A sector with a high density of trampling paths, the bare sand area surrounding a beach bar in 2007 (A) and full recovery in 2021 (B). A sector with a lower density of trampling paths and a large bare sand area associated with a car park in 2015 (C) with recovery of the bare sand area in 2021 (D) and partial recovery of the trampling paths. The red lines represent the pathways mapped in 2021, which have been retained in the 2015 image to allow a better comparison of the evolution. Google Earth images June 2007, May 2015 and May 2021.
